Thermal Growth Case Study

By John Lambert

In this article we will study the effects of thermal growth of a pumping unit used as part of a manufacturing plants process.

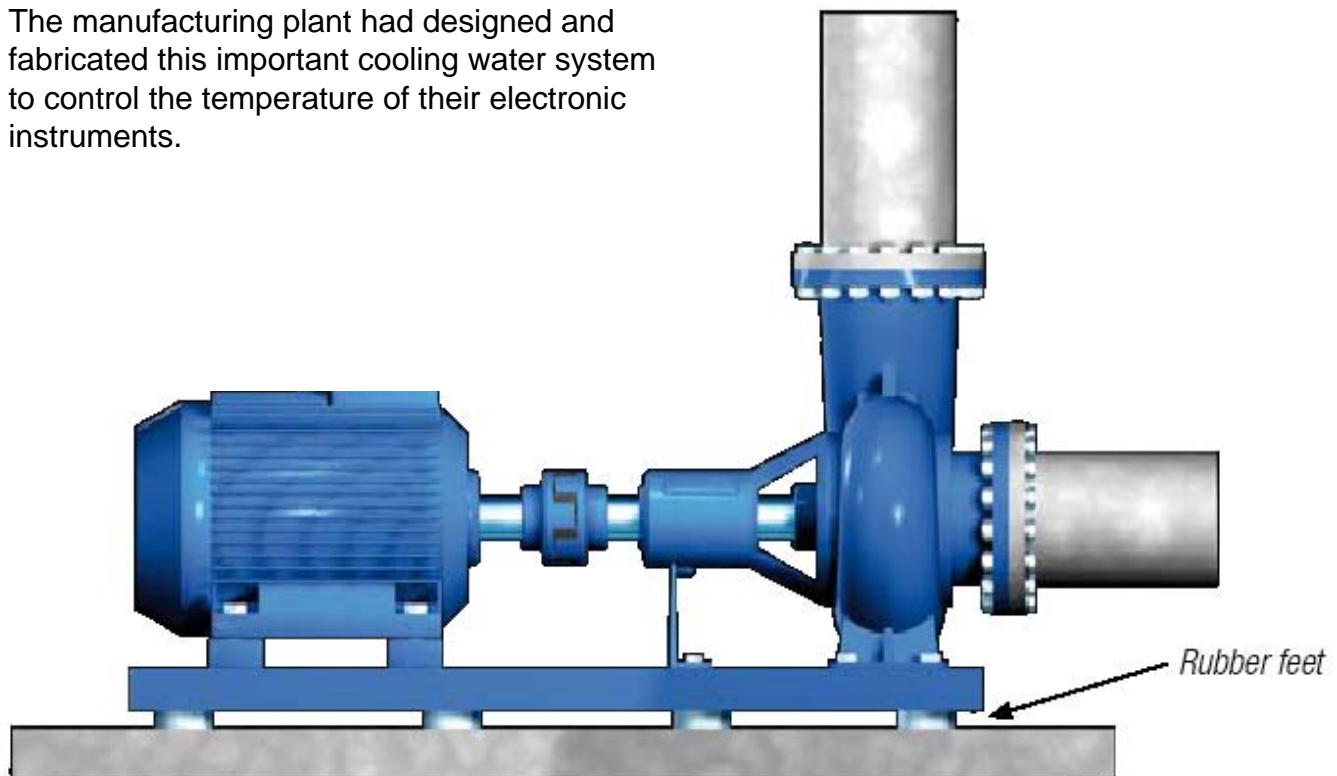
The machine units are mounted on a steel base plate which in turn is supported on special rubber mounting pads and secured to a strong foundation.

The manufacturing plant had designed and fabricated this important cooling water system to control the temperature of their electronic instruments.

This is important because if you lose the cooling you could also lose the electronics which would result in the replacement of some components and something even more costly – down time. The system is quite simple consisting of a motor, pump and a filter unit. However, you can see by the size of both the inlet and outlet of the piping system (approx 250mm 10”inches) that it has a fairly large capacity.

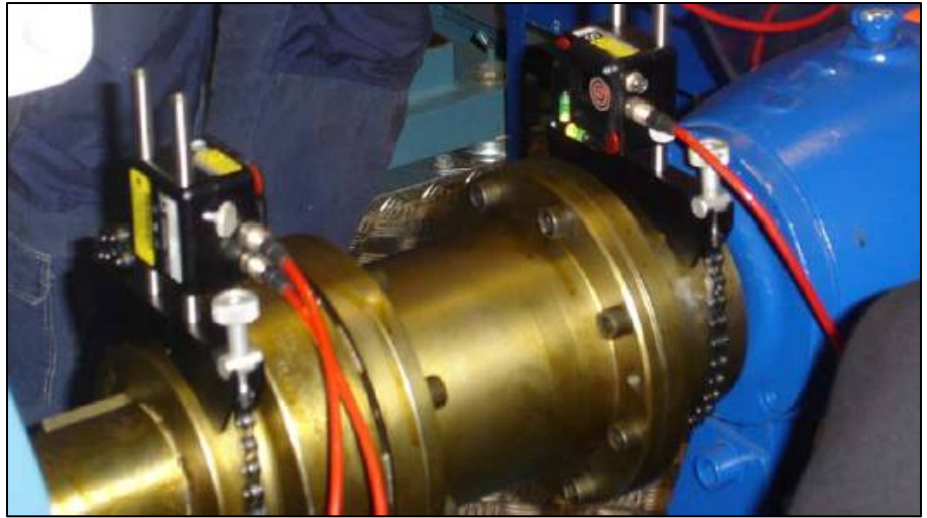
Cold alignment

A specified thermal growth compensation calculation was also used which meant that the motor was set high in order to compensate for the growth of the pump.

This was based on the knowledge that the pump became 15 degrees Celsius warmer than the motor during operation.

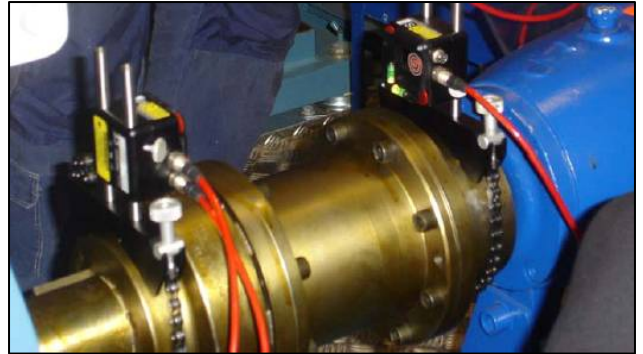
Hot alignment

First, we performed a shaft alignment measurement in cold conditions using the thermal growth specification so that we could verify and document the exact position of the motor and pump shafts compared to each other. We then started the machine and when it had reached its maximum working temperature we quickly shut it down and locked it out.

Once again we performed a shaft alignment measurement. By doing this “hot alignment” we could see how the thermal growth had changed the alignment.

The results were very good matching the calculated thermal growth. We were within tolerance so this could not be a cause for increased vibration levels. Nor would it have caused the damage of the pump shaft.

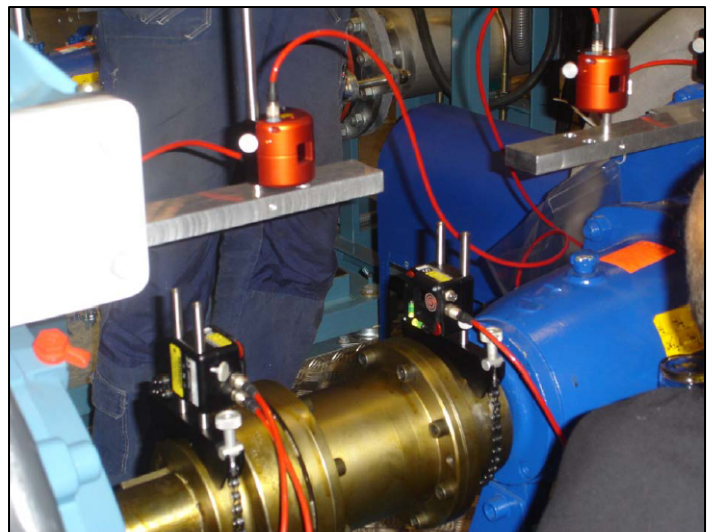
Although performing a hot alignment gives you a good indication of the thermal growth of the machine units, it does not give you a real time measurement. To do this we then used our D23 Easy-Laser® Spin laser transmitter and four D6 Spin-detectors (2 of which are shown in the picture) which we connected in series. We produced two (2) brackets which were mounted on the pump and motor. On each bracket we then mounted two (2) detectors.

The laser transmitter was placed on a stand on the floor and was levelled so that we could read the spirit levels. This allowed us to confirm that the transmitter did not change its position during the measurement.

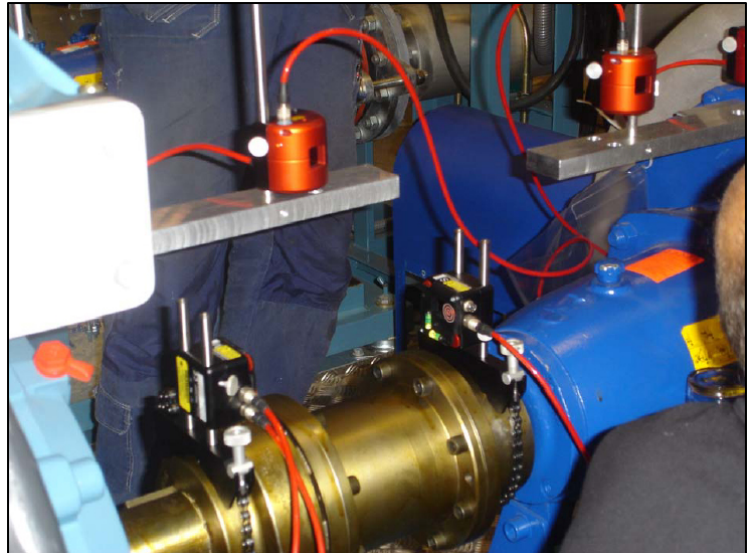
The detectors were then adjusted on the mounting rods so that the beam swept the detector surface in the midst of its range. Program 33 (rotation) was used on the display unit which then showed the four (4) detectors with real time measurement readings at the same time. Next we zeroed set the detectors on the display unit.

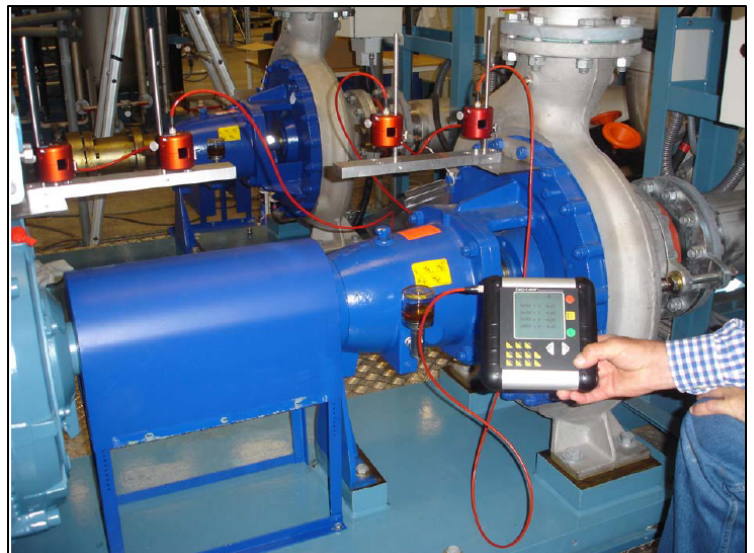
We could now read how both the motor and the pump changed their position compared to each other. It showed that the rear part of the pump rose 0.019"thou (0,5 mm) and tilted downwards 0.011" thou (0,3 mm) at the centre of the shaft compared to the centre of the motor shaft. These measurement values did not correspond with the values that we had received in the hot alignment condition.

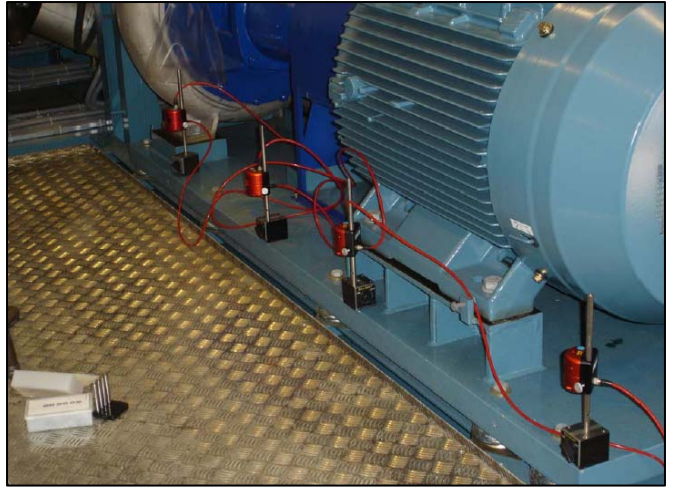
We then decided to investigate whether the base, which is a solid steel plate with the dimensions of thickness 2.4" (60 mm), width 39" (1000 mm) and length 78" (9200 mm), was moving or not. To do this we mounted the four (4) detectors on the base we wanted to measure and placed the Laser transmitter on another base which was not being used.

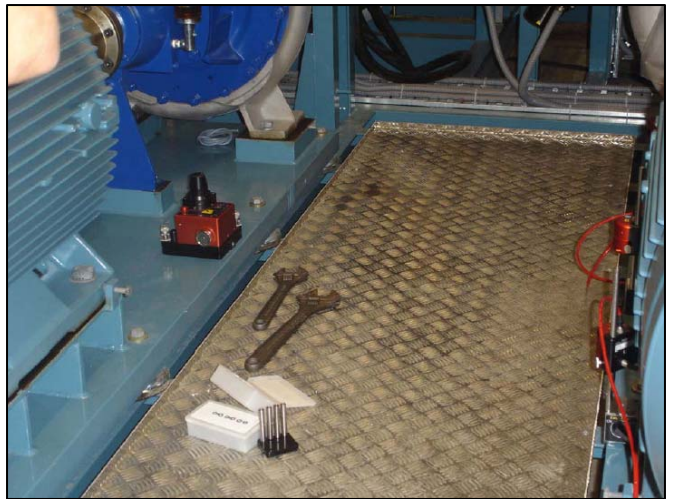
The transmitter was secured by its magnetic base and it was levelled, each detector was set to zero. We then started the motor and ran the machine unit at its full capacity and at its maximum operating temperature. The measurement results showed that the rear part of the base rose 0.019" (0,5 mm) and flexed 0.007" (0,2 mm) in the middle.

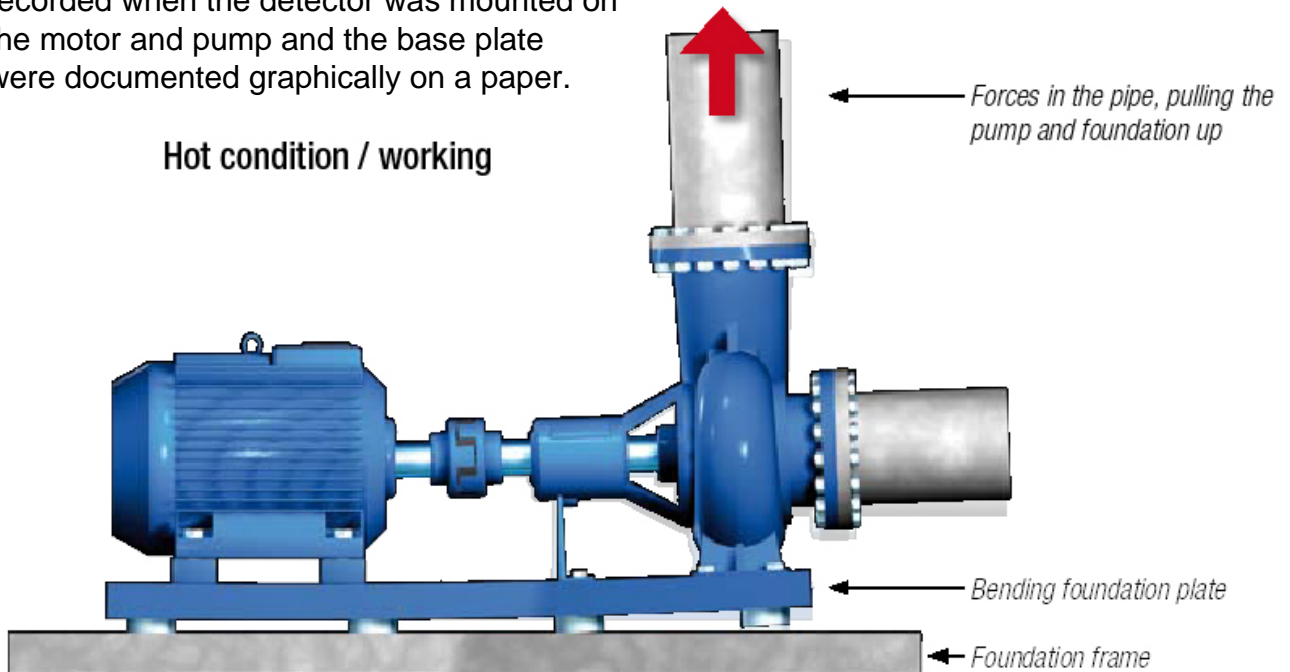
All the measurement values that we recorded when the detector was mounted on the motor and pump and the base plate were documented graphically on a paper.

We could then clearly see the position of the pump shaft centre in relation to the motor shaft centre when the machine units were running and under full load.

The force of the connecting pipe on the pump lifted the whole base which flexed at the middle. This was the cause of the large offset and angular misalignment between the pump and motor which then created increased vibrations. Based on the facts of the measurement results we recommended that the customer strengthen the base and modify the piping support and also to consider using a flexible joint between the pipe connection and the pump to minimize the force.
